Special Report 79-27

# EXTENDING THE USEFUL LIFE OF DYE-2 TO 1986

## PART I: PRELIMINARY FINDINGS AND RECOMMENDATIONS

Wayne Tobiasson, Charles Korhonen and Robert Redfield

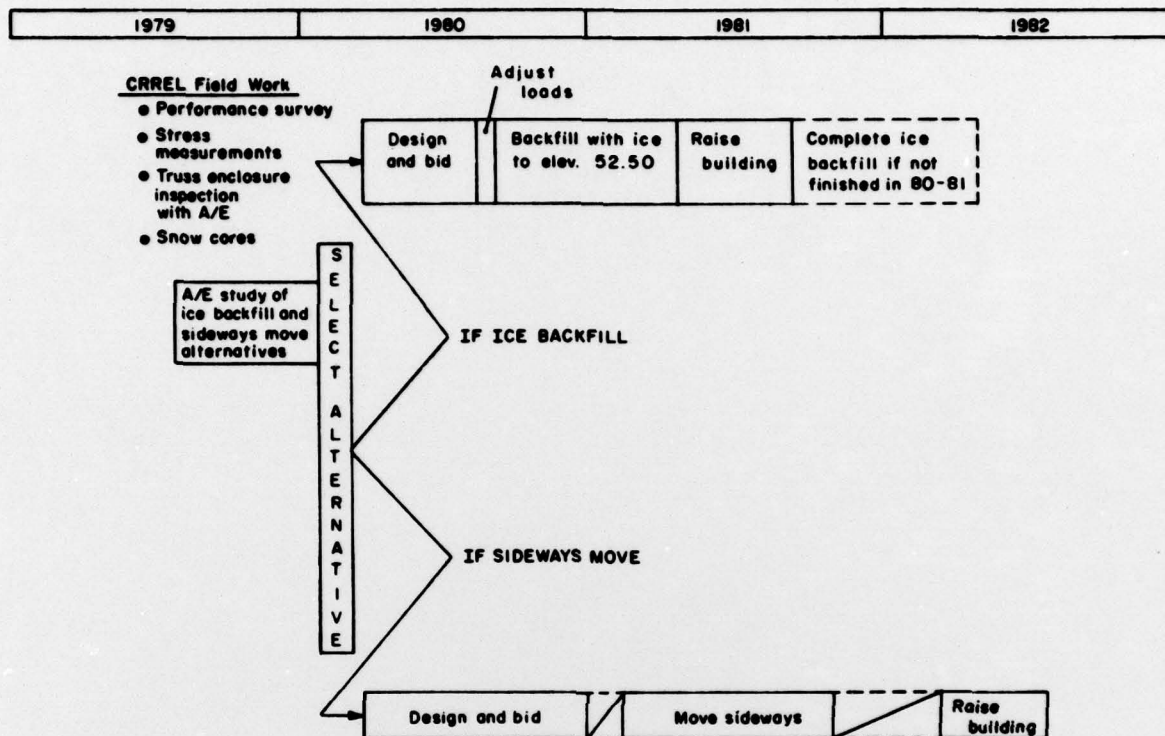
Figure 5. Time chart for DYE-2 work showing both the ice backfill and sideways move alternatives.

Metcalf and Eddy or another qualified architectural-engineering firm should conduct a technical and economic investigation of the ice backfill and sideways move alternatives during 1979 and should recommend a course of action to the Air Force early in 1980.
